Insight

The Hollow Building

By Joseph W. Lstiburek, Ph.D., P.Eng., Fellow ASHRAE

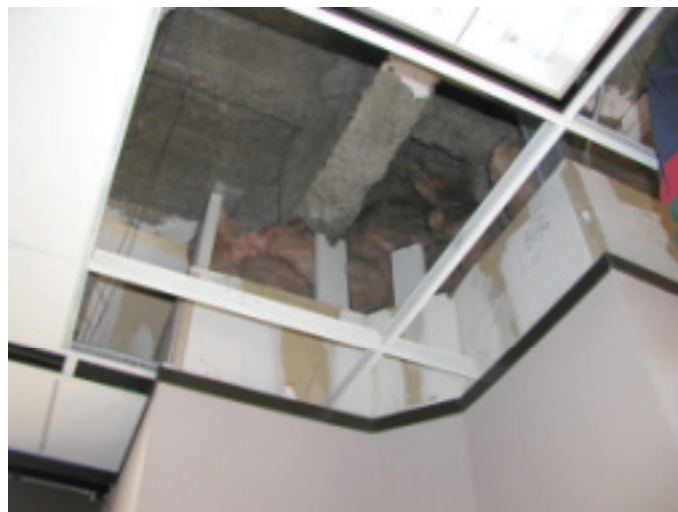
Photograph 2: Lack of Closure

The gypsum board does not extend to the underside of the floor assembly above. Note the discolored insulation due to the filtration effect of dust being retained as exterior air is pulled through insulation into the return plenum.

If I were in charge I would ban dropped ceiling return air plenums (**Photograph 1**). You just know that the interior gypsum board lining does not extend to the underside of the floor or roof system of the majority of buildings (**Photograph 2**). And even if it does it is rarely sealed. As a result exterior air is sucked through the air porous insulation right into the return plenum. If the outside air is humid, and if the space is air conditioned we lose control of the relative humidity in the dropped ceiling and the ceiling tile begin to smell like vomit (really - the butyric acid found in ceiling tile does smell like vomit as the relative humidity goes up) or the space smells like dirty socks (really - bacteria growing on coils from a moisture load the designer did not anticipate does smell like dirty socks). What are the odds? I can't tell you the number of buildings we have had to go into and retrofit a closure at the plenum to exterior wall connection (**Photograph 3**). This is another example of problems that result from the widespread failure to provide a continuous air barrier system in a building.

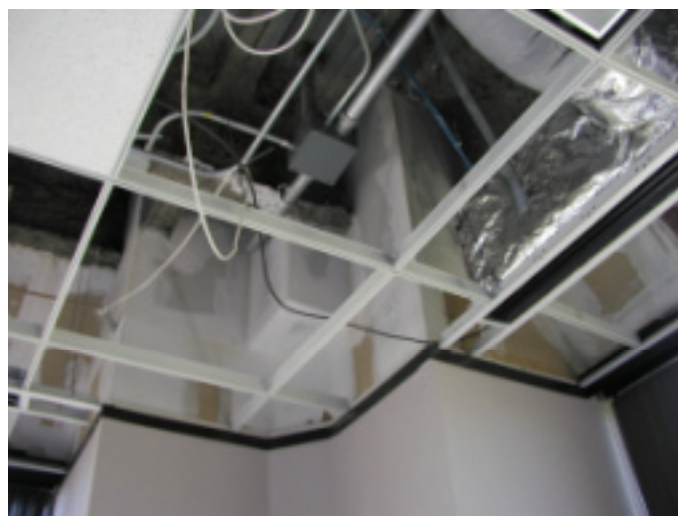
Photograph 3: Retrofit of Closure

Gypsum board extended to underside of floor assembly and sealed creating closure.

exterior wall to the floor above and the floor below creating a continuous air barrier. Note: mineral wool meets the fire requirements but does not stop airflow, so don't shove mineral wool into a gap that leads between floors and think you have done a good deed - fire-rated foam, mastic or sealant needs to be used.

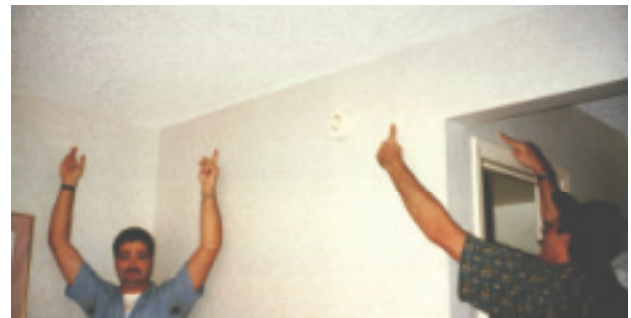
Photograph 4: Hotel Room Flow Path Part I

Dropped ceiling connected to interior wall connected to demising wall connected to exterior.

above the bathroom. It is not practical to seal this duct airtight – although attempts are made. When this duct “leaks” it draws air from the dropped ceiling depressurizing it. This dropped ceiling is connected to the demising wall that separates units and this demising wall extends to the exterior (Photograph 4). This demising wall is now a “duct” that pulls air from the exterior and supplies it to the dropped ceiling (Figure 4). If the outside air is humid, and if the space is air conditioned, and if the walls are covered with vinyl wallpaper we get mold (Photograph 5). What are the odds?

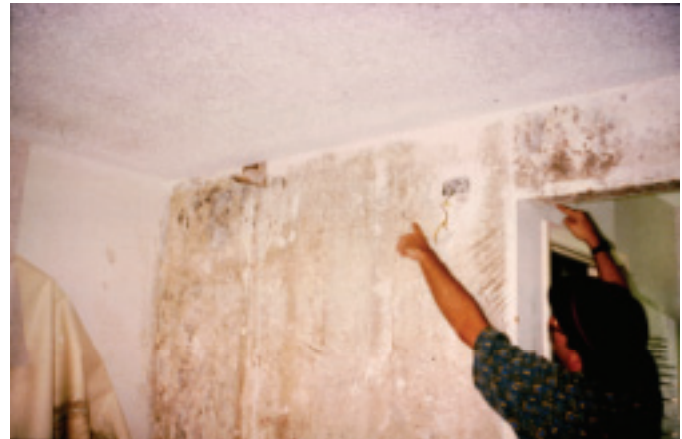
Photograph 5: Hotel Room Flow Path Part II

Mold on interior wall resulting from exterior humid air being pulled into demising wall as a result of negative pressure field created by leakage of exhaust fan in bathroom dropped ceiling.

So what to do in this case? Provide a continuous air barrier at the exterior wall. Add a grille in an interior wall that bounds the dropped ceiling near the ceiling where this interior wall connects to the demising wall to “bleed” the pressure so that a negative pressure field is not set up in the demising wall. Do not add a grille to “bleed” the pressure in the demising wall as this will cause the fire protection engineers head to explode – as well as violate the smoke and fire rating of the assembly. And oh yes, don’t install vinyl wall coverings.

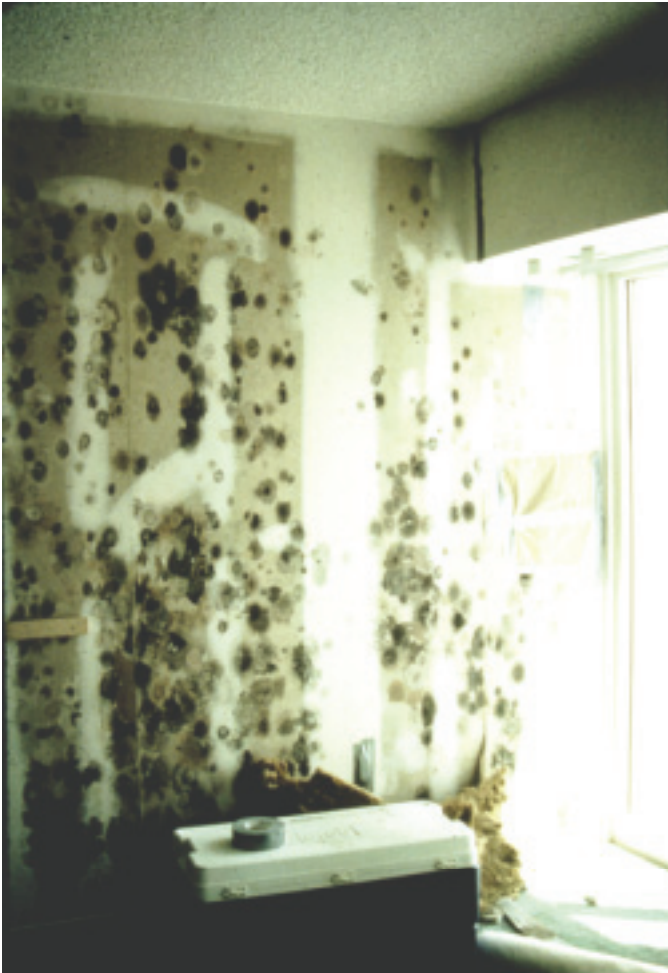
Photograph 6: Demising Wall Mold

Mold on demising wall due to coupling of fan coil unit return plenum to demising wall creating flow path between exterior and interior.

enclosures give me heartburn. These units have a supply duct (really a short sleeve extending from the unit that blows air into the room). But these units rarely have a ducted return. They use the gypsum board to create a “return plenum” and a “filter grille” is installed in the underside of the gypsum board creating the unit closure. As the filter gets dirty the negative pressure in the gypsum board enclosure increases (**Figure 5**). This gypsum board enclosure connects to the demising wall and the demising wall connects to the exterior (**Figure 6**) creating a “wall duct” that draws in exterior air leading to mold (**Photograph 6**).
